EQUIPMENT:	DIGIT and DIGIT CD exciters	BULLETIN NO:	FM- 580-WCF
		Part No:	773-5000-020
		DATE:	November
			2008
UNITS AFFECTED:		ECN NO:	47034
		PAGES:	4
PURPOSE:	Power Amplifier Self Oscillation (C29 Replacement)

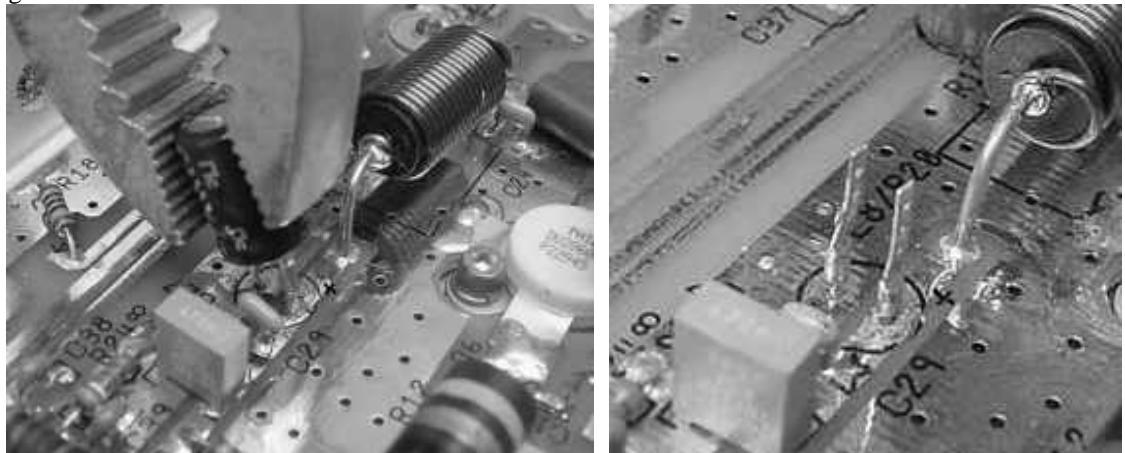
Figure 1

- 1. Place the PA on the bench with the heat sink down.
- 2. Remove the 12 screws holding the cover in place.
- 3. Using pliers (fingers work as well), gently rock the capacitor side to side. This will work the leads loose from their internal connections to separate them from the capacitor (figure 1).
